LONG-TERM PERFORMANCE OF EXTERNAL THERMAL INSULATION SYSTEMS (ETICS)

Helmut Künzel, Hartwig M. Künzel, Klaus Sedlbauer

Fraunhofer-Institute for Building Physics, Holzkirchen, Germany

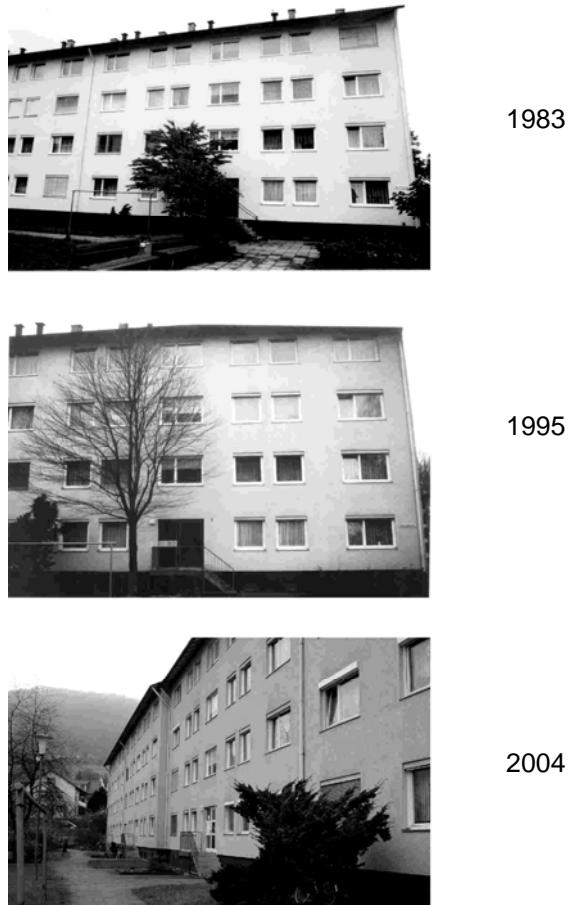
Figure 2 shows the northern façade of object 52 (residential building in Geislingen) at three different times. Despite variations in the quality of the photographs, no important or harmful change is to be observed over a period of 23 years. On the western sides of parallel located residential buildings in Geislingen (objects 30 to 33), however, partial development of algae has occurred. It is remarkable that the algae growth did not change within the period between the two inspections (Fig. 3). The neighbouring object,

Fig. 2. Northern façade of object 52 in Geislingen at three different times: 2, 14 and 23 years after refurbishment in 1981 from slightly different angles. The slowly growing conifer can be seen in all photographs; the deciduous tree was cut before 2004

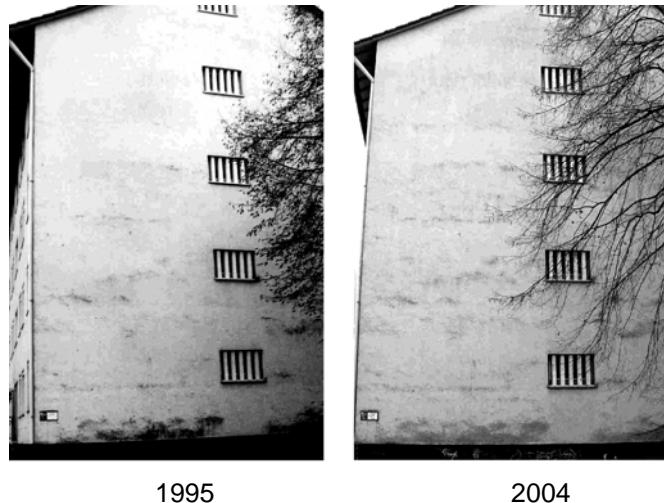
Fig. 3. Western gable side of object 31 in Geislingen 14 years (left) and 23 years (right) after refurbishment in 1981 with algae growth in the plinth area and some horizontal stripes, caused by irregularities in the plaster structure in relation with the working levels of the scaffold. The tree has grown visibly; the algae infestation remained unchanged with a slight increase in the upper façade area

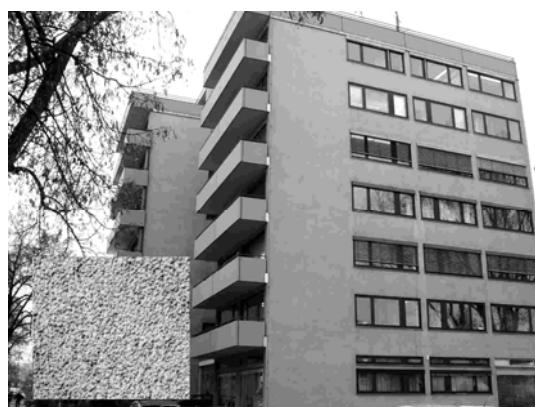
Figure 4 shows the eastern and southern façades of object 54 in Neumarkt. The evenly spread pollution provided a kind of patina within a period of 16 years. On the northern façade (adjacent to the road) of object 51 in Nuremberg no microbial growth occurred after a first refurbishment by applying a coating 17 years ago. In this case, the cleaning effect prevails due to the drainage of rain water, concentrating between the windows (Fig. 5).

Fig. 4. Eastern and southern façade (from right to left) of object 54 in Neumarkt in December 2004, 16 years after refurbishment in 1988 by applying a new coating, close-up view of the plaster at the small window

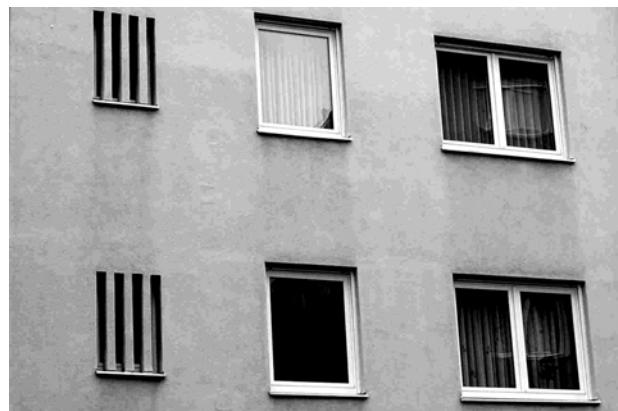
Fig. 5. Partial view of the northern façade of object 51 in Nuremberg, 17 years after refurbishment by applying a new coating in 1987. The areas between the windows, which are exposed to intense rain, are somewhat lighter, meaning that the exposure to rain did not cause the growth of algae but had a cleaning effect

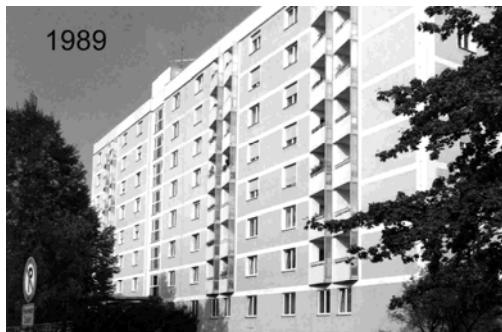
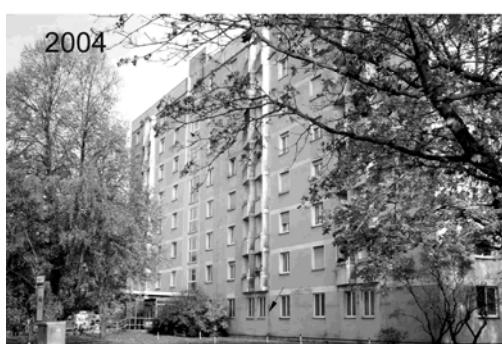
The state of the western façade of object 16 (old people's home in Munich) in 1989, three years after the application of an ETICS, is documented by Figure 6 above. There were no visible defects. But during the inspection in 2004, 15 years later, algae growth could clearly be observed (Fig. 6, below), especially in areas with a intense exposure to rain (Fig. 7).

Fig. 6. Western façade of object 16 (old people's home in Munich) in September 1989, three years after application of an ETICS and another 15 years later in November 2004 (the difference in colour does not mean that the façade has been repainted, it is due to coloration problems with digital photography). The formation of algae is clearly visible especially in areas intensely exposed to rain (see arrow and Fig. 7)

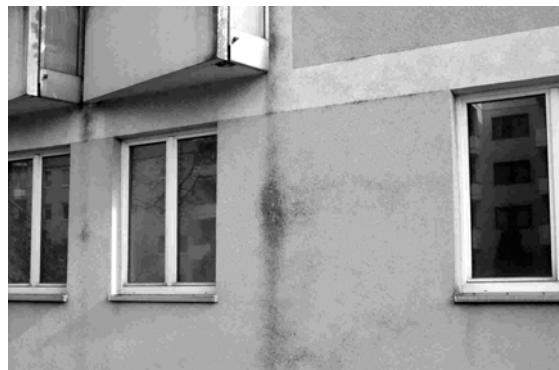
Fig. 7. Local growth of algae along areas with a concentration at the rain water runoff path, caused by the lateral limitation of the balconies and the wind. The growth of algae is clearly smaller in the area immediately below the balcony plate than in the unprotected wall areas

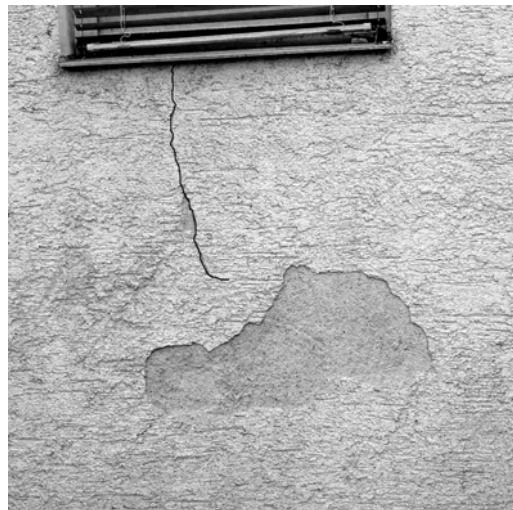
Fig. 8. Crack in the wall and damage of plaster on the western façade of the neighbouring building of object 32 without an External Wall Insulation System (Ebertstraße 2). A crack in the wall below the window is occurring in the plaster. The final rendering has partially separated from the undercoat plaster. Such damage can generally be avoided by means of a thermal insulation composite system with the help of the de-coupling effect of the soft insulation layer as well as plastic additives and the reinforcement of the plaster

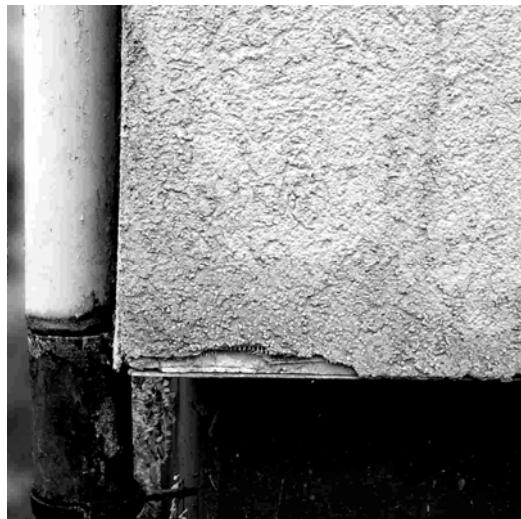
Continuous maintenance is necessary for the façades of buildings. It is not only necessary to renew the façade coating due to pollution and weathering from time to time, but also to check and repair the “weak spots” on all façades, where necessary. Such weak spots may be connections around windows or façade connections as shown in Figure 9.

Fig. 9. Example of a damage in the lower area of the façade on the western side of object 31 by permeation of moisture at the connection profile (maybe influenced by a defective rain-water pipe). Such damages should be repaired early enough and separately from other general façade refurbishments
