LONG-TERM PERFORMANCE OF EXTERNAL THERMAL INSULATION SYSTEMS (ETICS)

Helmut Künzel, Hartwig M. Künzel, Klaus Sedlbauer

Fraunhofer-Institute for Building Physics, Holzkirchen, Germany

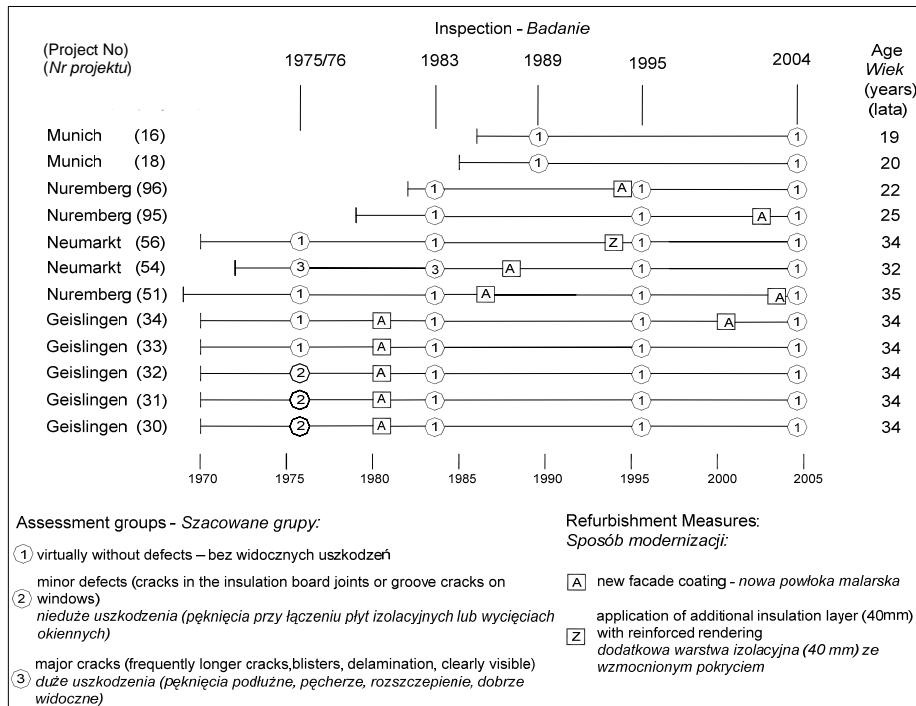
The investigated objects together with details regarding location, the type of applied External Thermal Insulation Composite System (ETICS), data on the building and refurbishment measures are indicated in Table 1. The diagram in Figure 1 shows the times of ETICS application, inspection and the assessment of the state. As a result the following may be deduced:

Fig. 1. Diagram showing the times of application, inspection and refurbishment of External Wall Insulation Systems in practice with notes on the state of the façades classified by means of the assessment groups specified above
